WL-TR-91-4032
DOT/FAA/CT-91/23
VOL II, Part 3

COMPOSITE FAILURE ANALYSIS HANDBOOK
VOLUME II - TECHNICAL HANDBOOK
PART 3 - CASE HISTORIES

R.J. Kar
Northrop Corporation
One Northrop Avenue
Hawthorne, California 90250-3277

February 1992

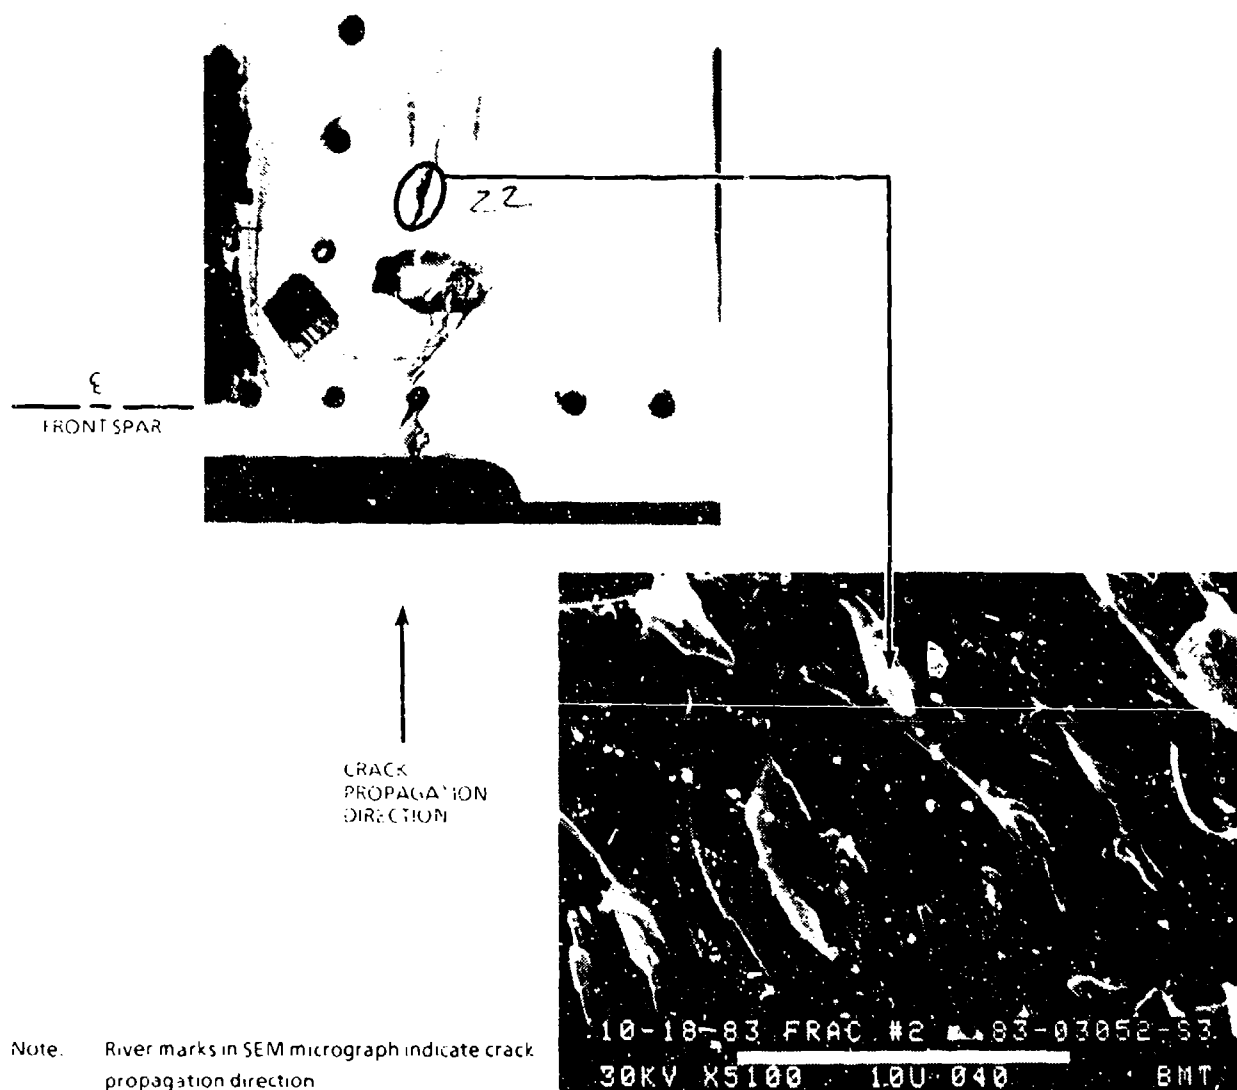
Since no discrepancies were identified in the above analyses, fractographic examinations were selected as the next investigative operation. Primary emphasis was placed on identifying the direction of crack propagation, origin, and any anomalous conditions that could be associated with fracture. To help in the examination, the delaminated interlaminar areas were removed from the skin panel and sectioned into approximately 6 inch by 6 inch squares and examined optically. The optical examinations were performed at 400 to 600X magnification, which provided a rapid and efficient means of identifying characteristic fracture features. Scanning electron microscopy (SEM) was performed on selected areas of interest requiring higher magnifications and to document specific fracture features identified during the optical analyses. The orientation of river patterns and resin microflow (Figure 2-2) observed on the fracture surface were used to generate a map of the local directions of crack propagation over the fracture surface. Although some areas of interlaminar fracture separated by shear loading (as evidenced by the presence of hackles and scallops), a majority of the fracture exhibited Mode I tension river mark features. SEM analysis of the translaminar

Figure 2-2. 737-300 Elevator Static Test Fracture Directions

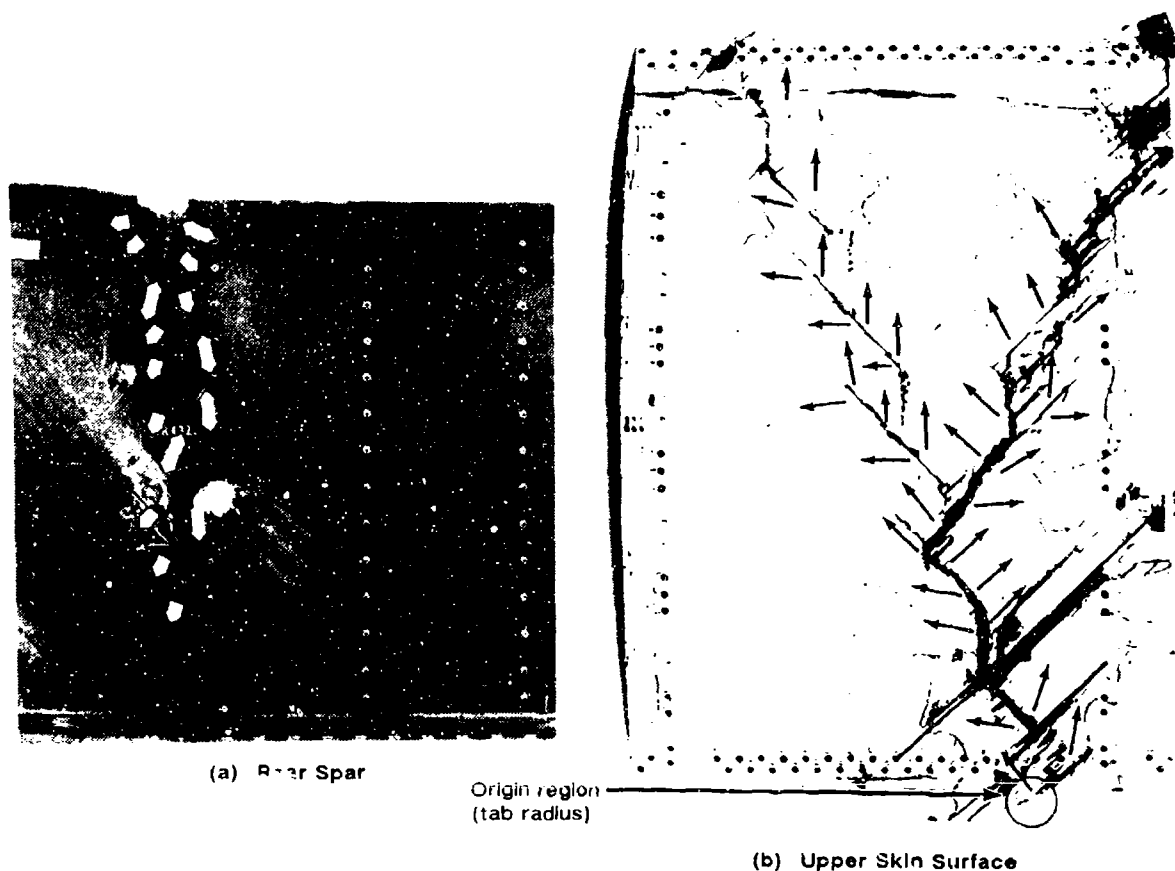
Using the outline of the delamination generated by NDE, the fractures were abrasively sectioned open to minimize artifacts. Detailed crack mapping of the delamination surfaces was performed by optical microscopy, with documentation of the fracture morphologies obtained by the SEM. Areas of delamination were found to be principally Mode I tension dominated, with localized Mode II shear regions. The overall crack growth directions, as well as the fracture origin regions for the upper skin surface and the rear spar are shown in Figure 2-8. These analyses revealed cracking of the upper skin initiated by compression buckling fracture mode at the trailing edge tab radius with resultant fracture propagating toward the leading edge. Similarly, the rear spar fracture originated in a region adjacent to the upper skin surface. Crack mapping in this region was very inconsistent, with a nearly random variation in the microscopic river marks and hackle orientation. No anomalous conditions such as porosity, resin starvation, or chemical contamination were identified in the origin regions.

Figure 2-8. JVX Wing Test Box Crack Mapping Results

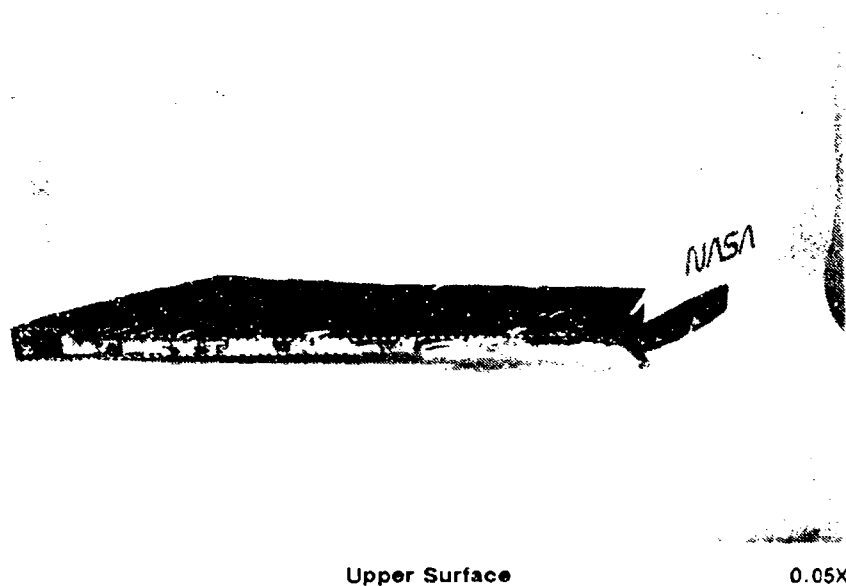
Figure 2-9. NASA HiMAT Test Wing in the As-Received Condition

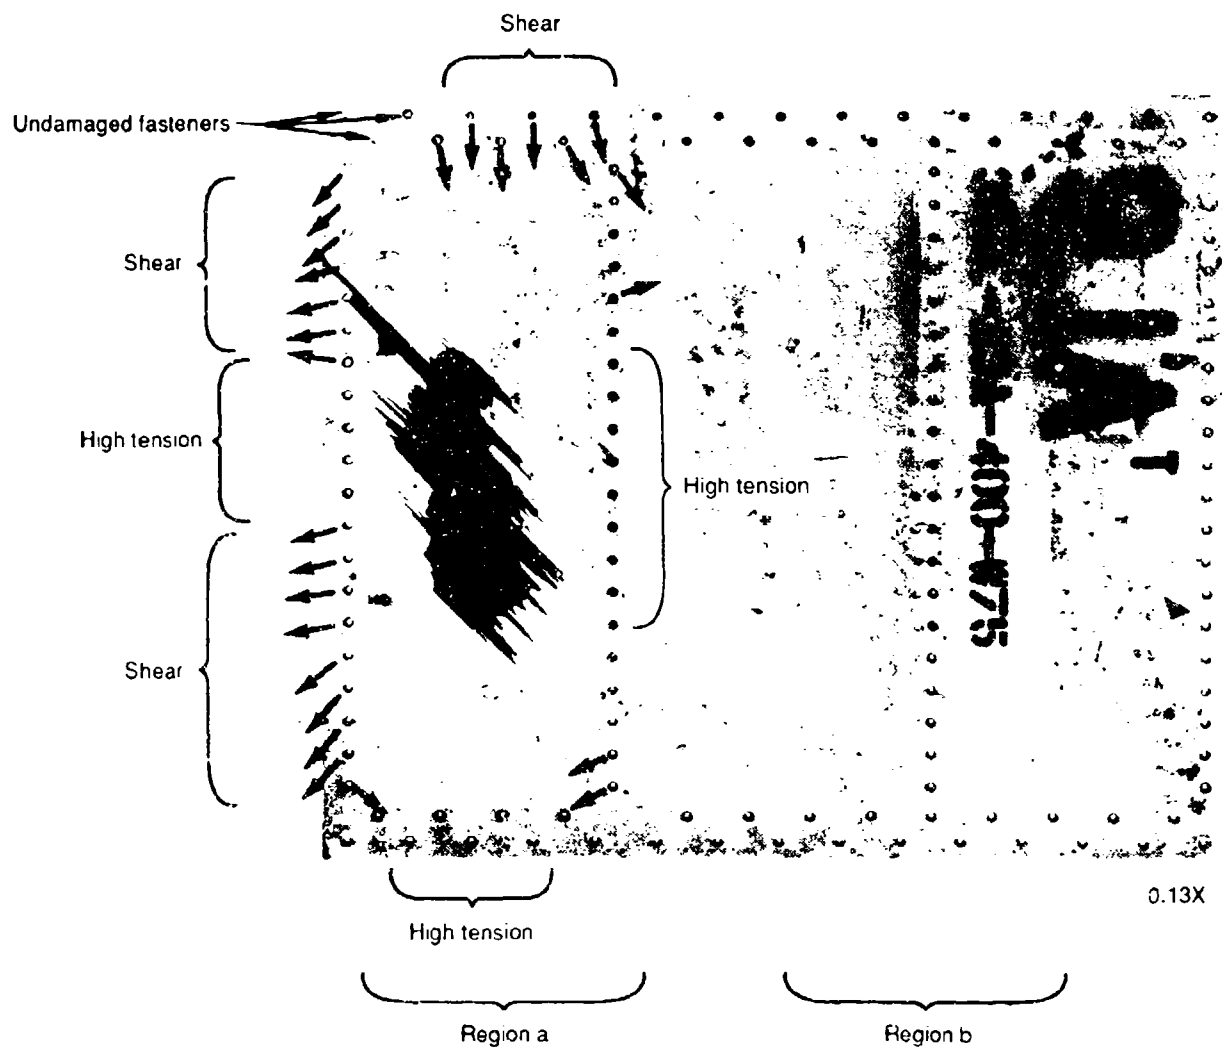
Figure 2-28. Mapping of the Fastener Hole Damage

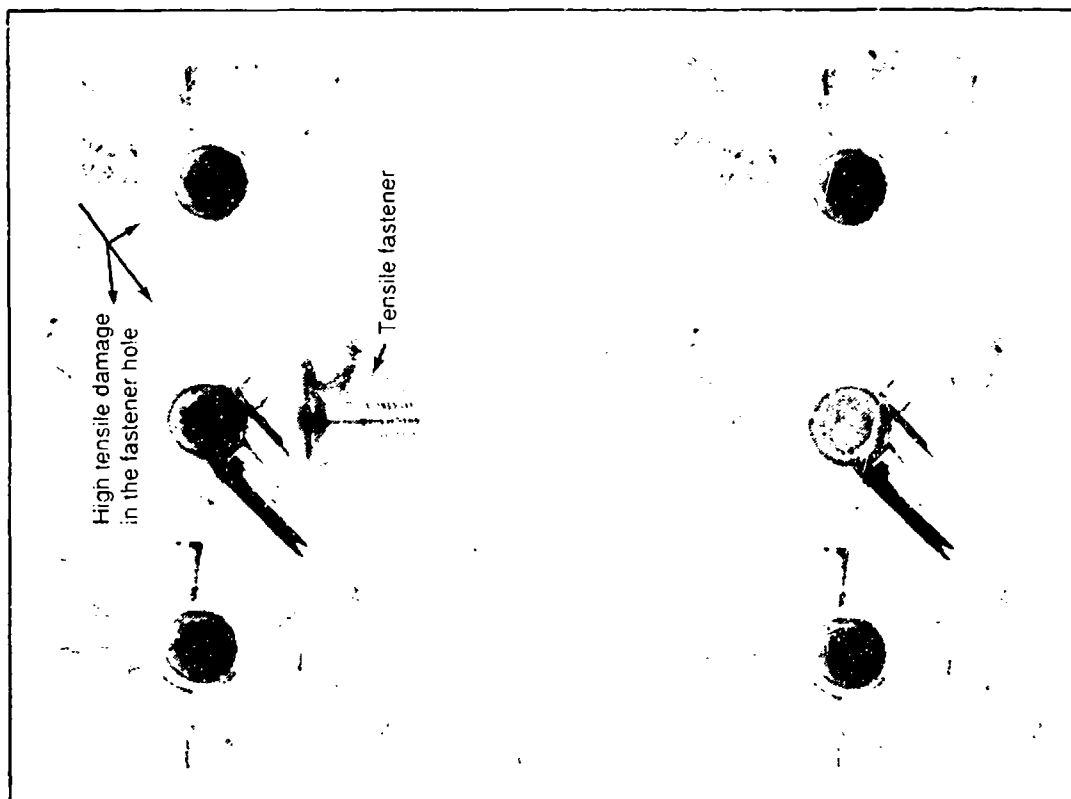
a. Tensile fastener (fits loosely in fastener hole) 0.9X

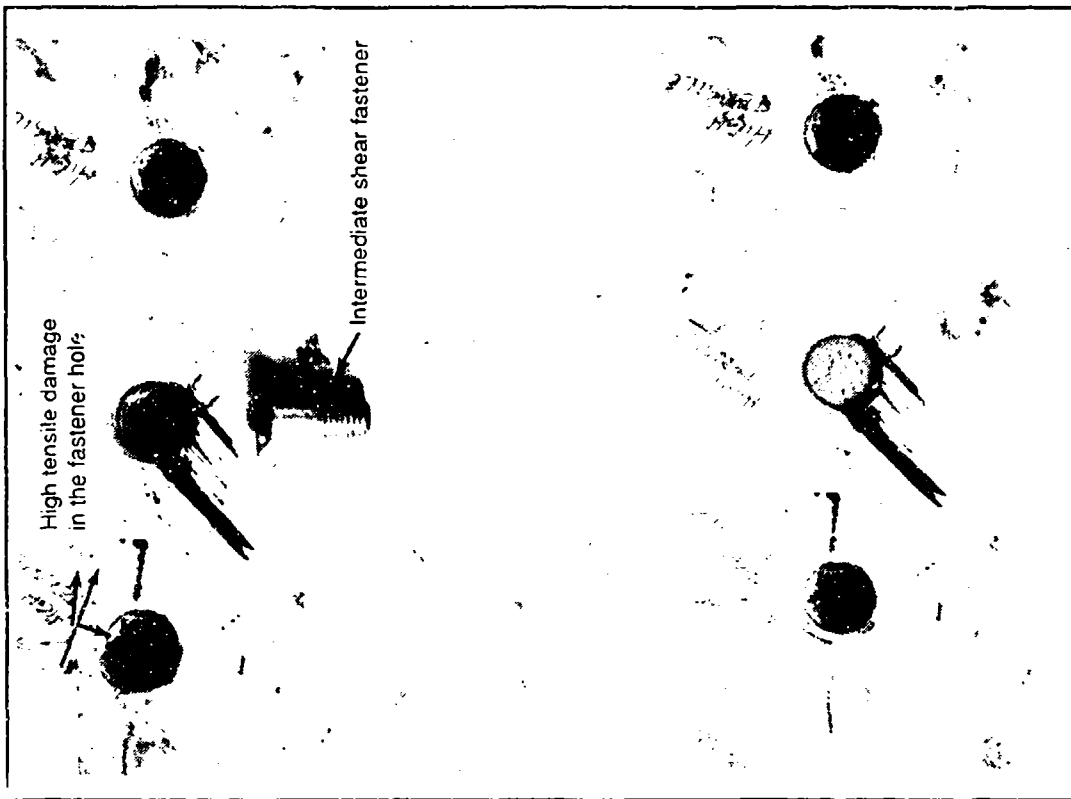
b. Shear (intermediate) fastener (fits snugly in fastener hole) 0.9X

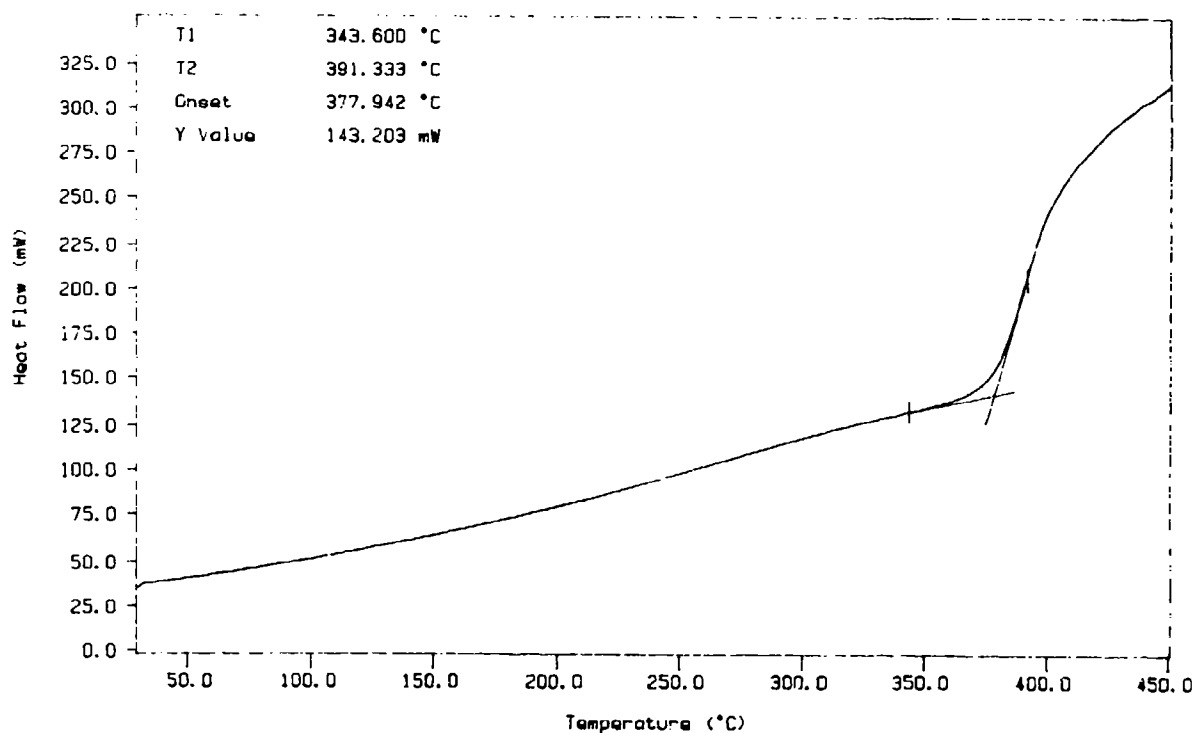
Differential scanning calorimetry (DSC) showed no exothermic peaks, indicating that the material was fully cured (Figure 2-33). A decomposition at 378°C was also observed. Thermomechanical analysis (TMA) showed the average glass transition temperature (T_g) to be 210°C (410°F, Figure 2-34). Thermogravimetric analysis (TGA) indicated the composite decomposed at approximately 357°C (675°F, Figure 2-35)

Figure 2-33. DSC Thermogram

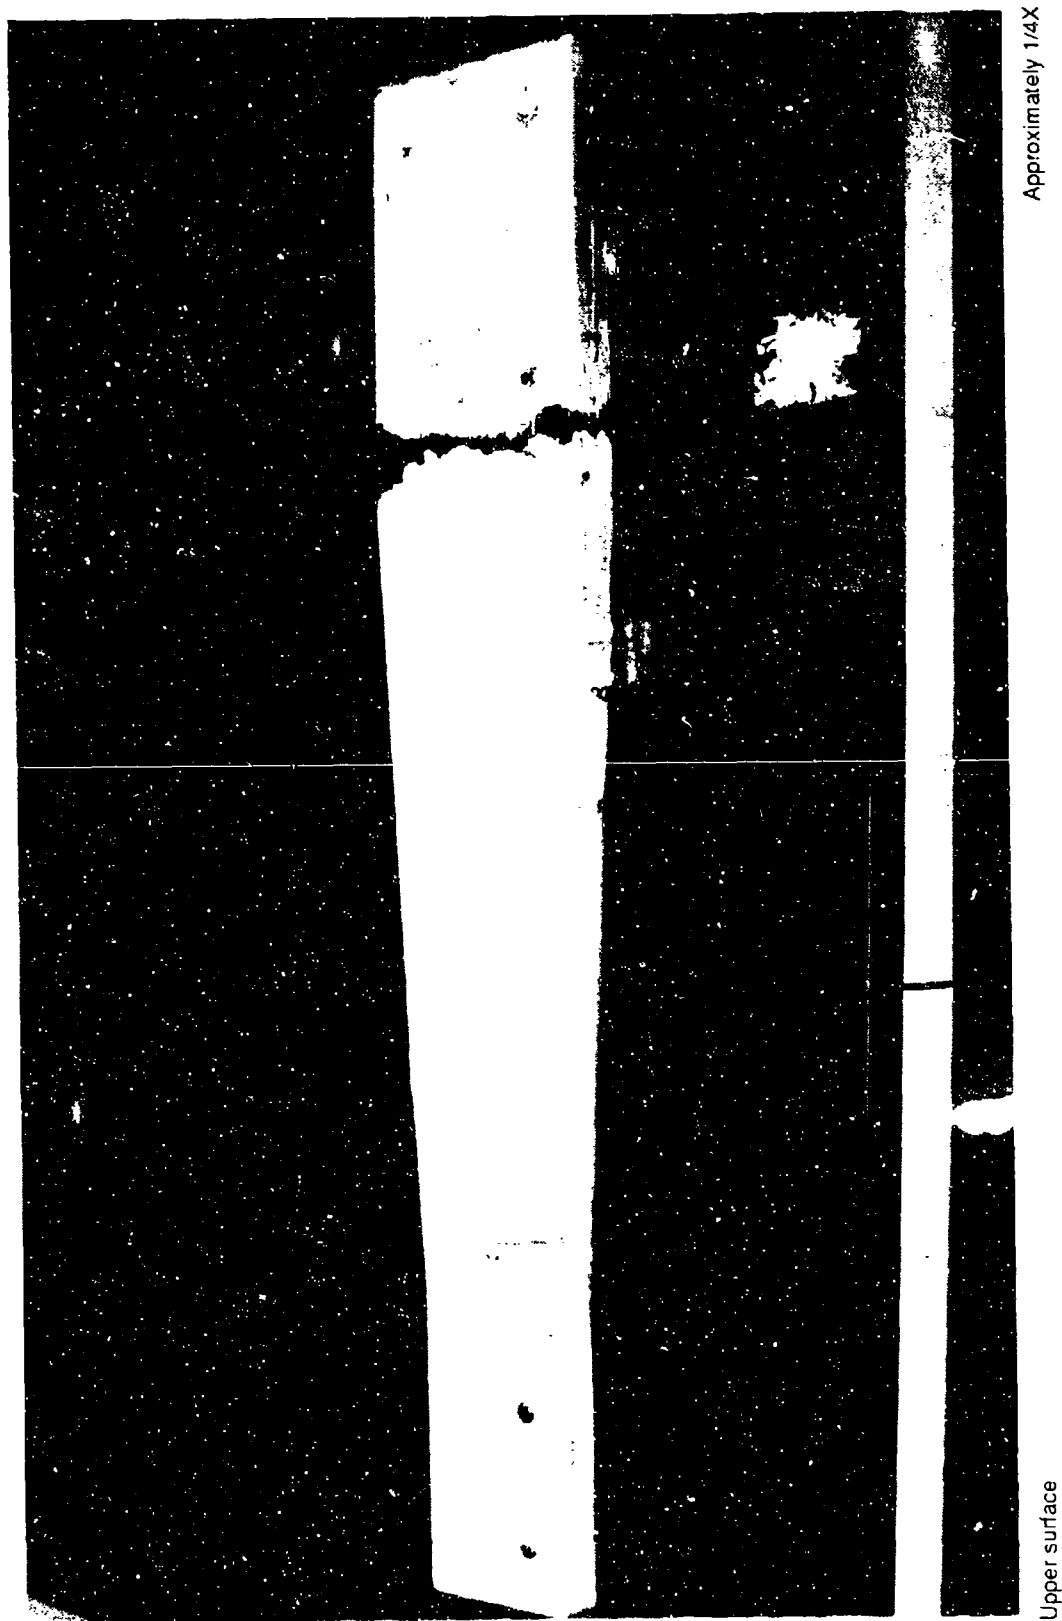
Figure 2-38. Macro photograph of the Upper Surface of the Landing Strut As-Received

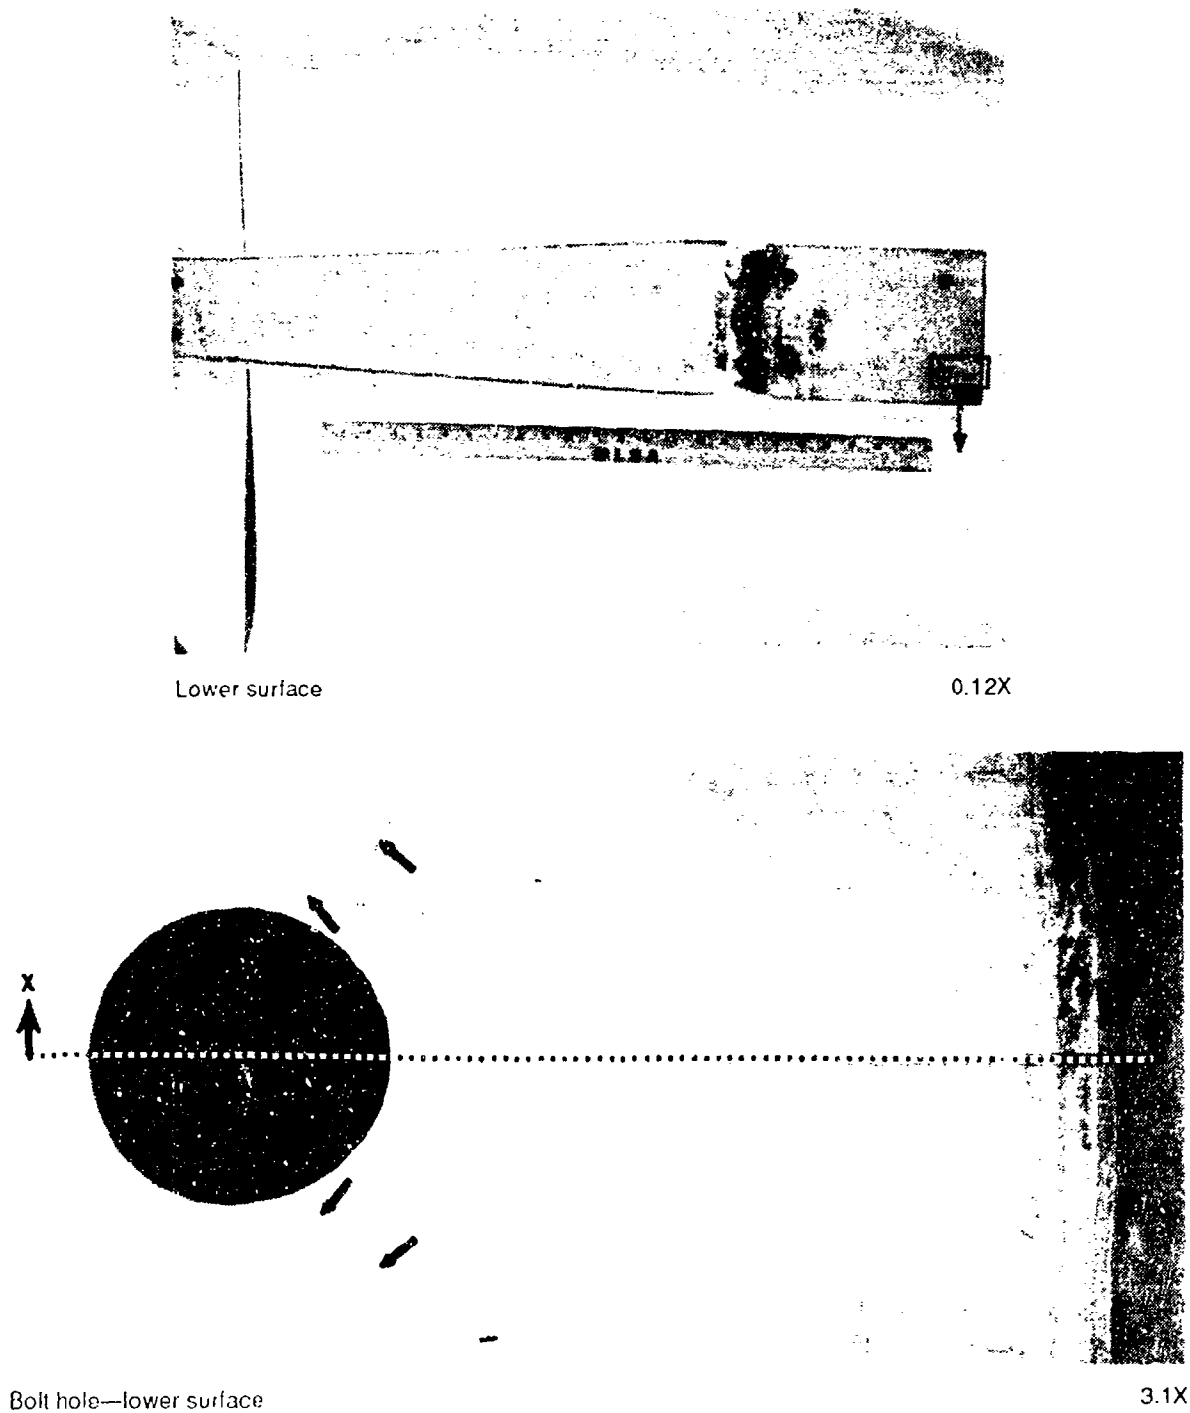
Figure 2-44. Macrophotographs of the Lower Surface of Strut

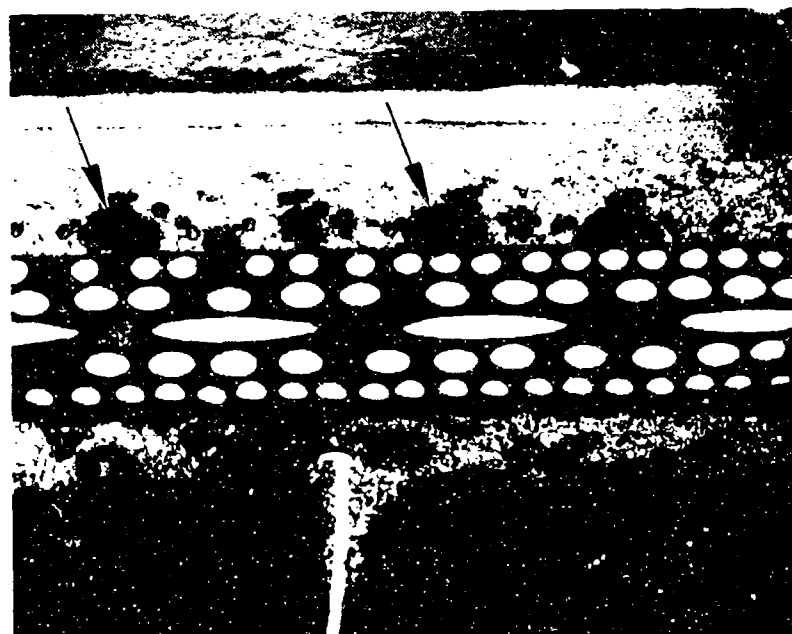
Figure 2-59. Photograph of Cross-Section Taken Through Rudder Skin
 Note Porosity in Skin at Arrows

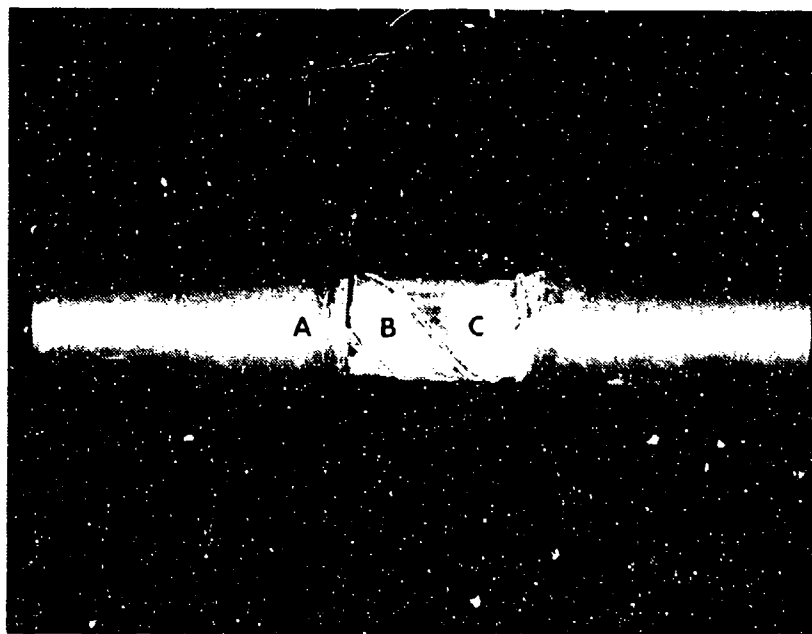
Figure 2-71. Photograph of Cylindrical Specimen After Sectioning to Expose Internal Damage

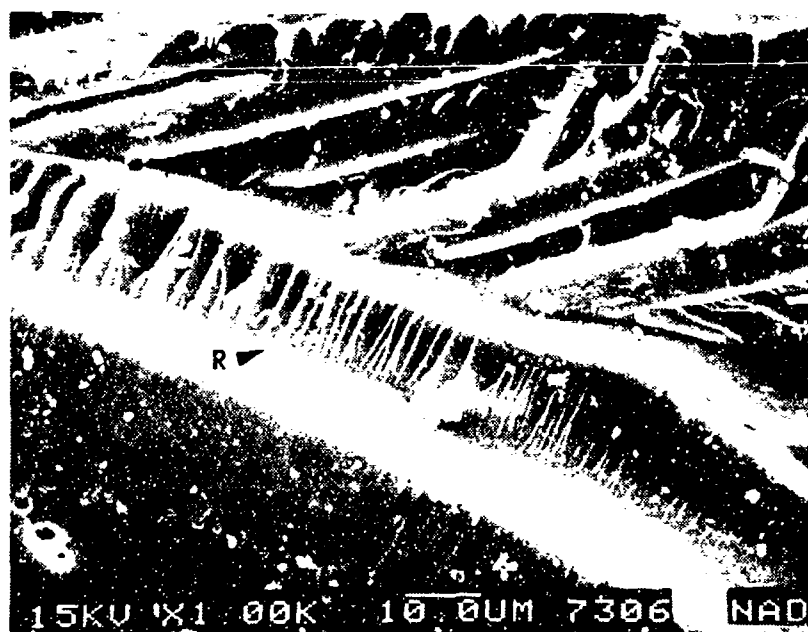
Figure 2-78. SEM Photographs in Region A of Delamination of Bottom Surface of Compound Plate
 (a) Mixed Cohesive-Adhesive Failure
 (b) Holes and Voids in Resin
 Note river patterns (arrow)

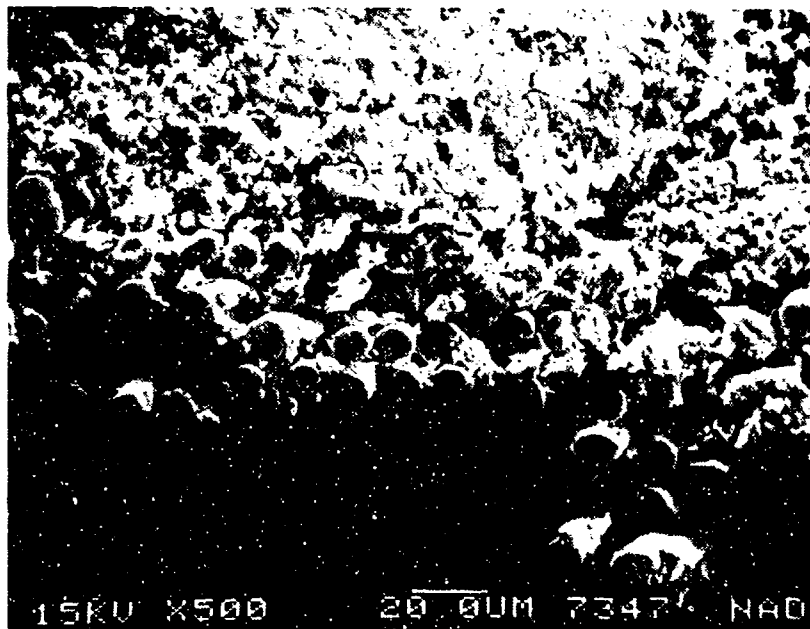
Figure 2-81. SEM Photographs of Bolt Hole Cross-Section in Bottom Surface of Compound Plate (Region D)
 (a) Compression Fracture of Fiber Ends
 (b) Porosity and Debris in Resin
